### **Semi-Annual Environmental Monitoring Report (July-December 2018)**

**Regional Urban Development Project (RUDP)  
Project Implementation Unit  
Biratnagar, Nepal  
ADB Loan 47252- NEP**

**Biratnagar Metropolitan City (BMC), Nepal**

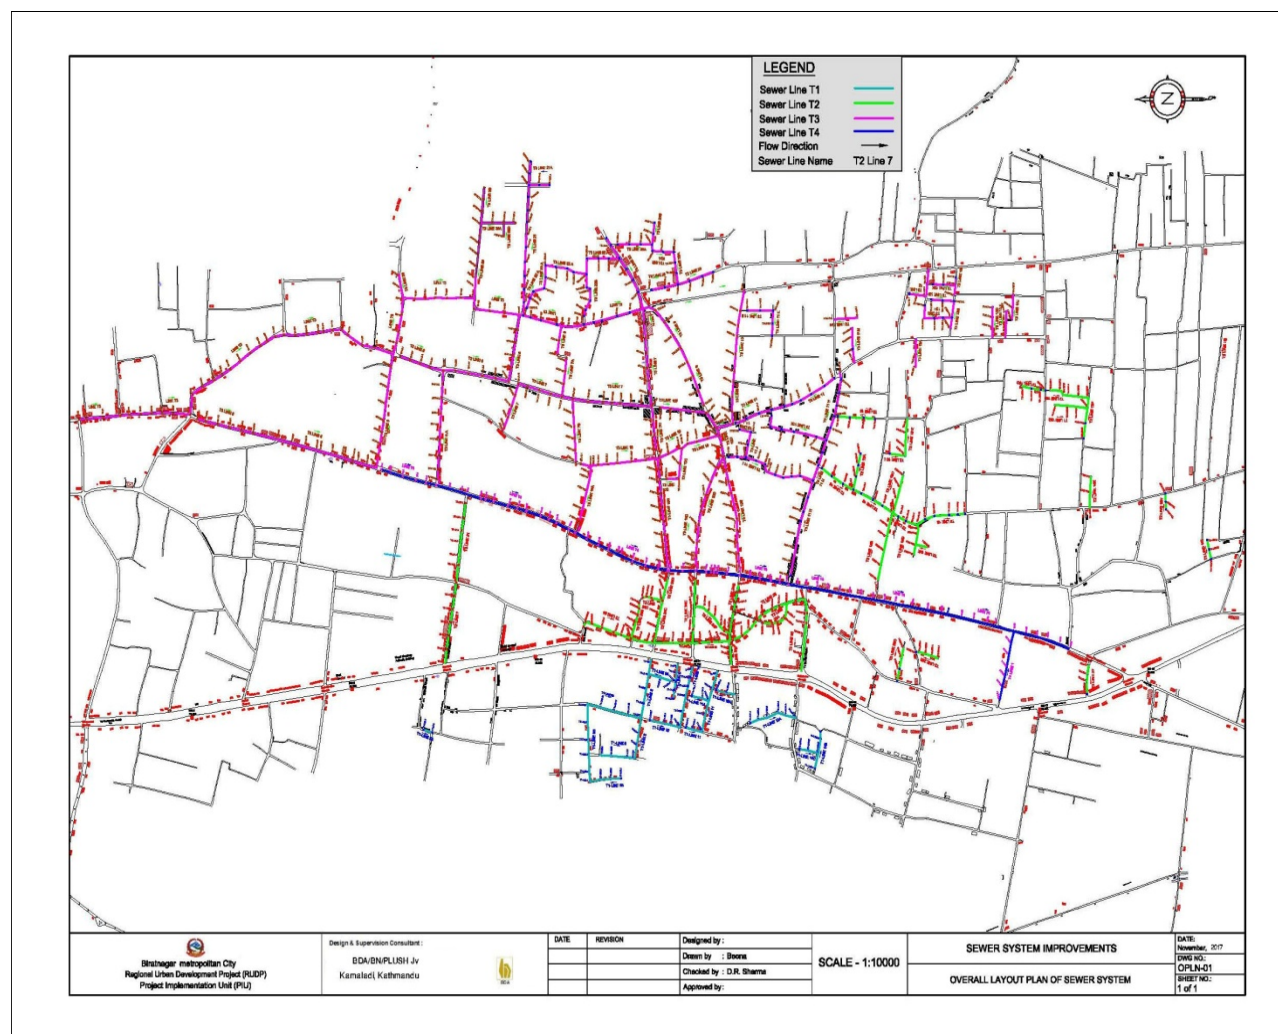
Figure 2: Sewerage Layout Plan

- 9 Total length of the proposed sewerage system will be 20.082 kilometers (kms). Similarly, 685 manholes are proposed in all sewerage sub systems. As indicated in design and drawings there will be 4 types of trunk and secondary sewerage system. Overall layout plan of the sewerage system as proposed for RUDP is given in *Figure 2*.

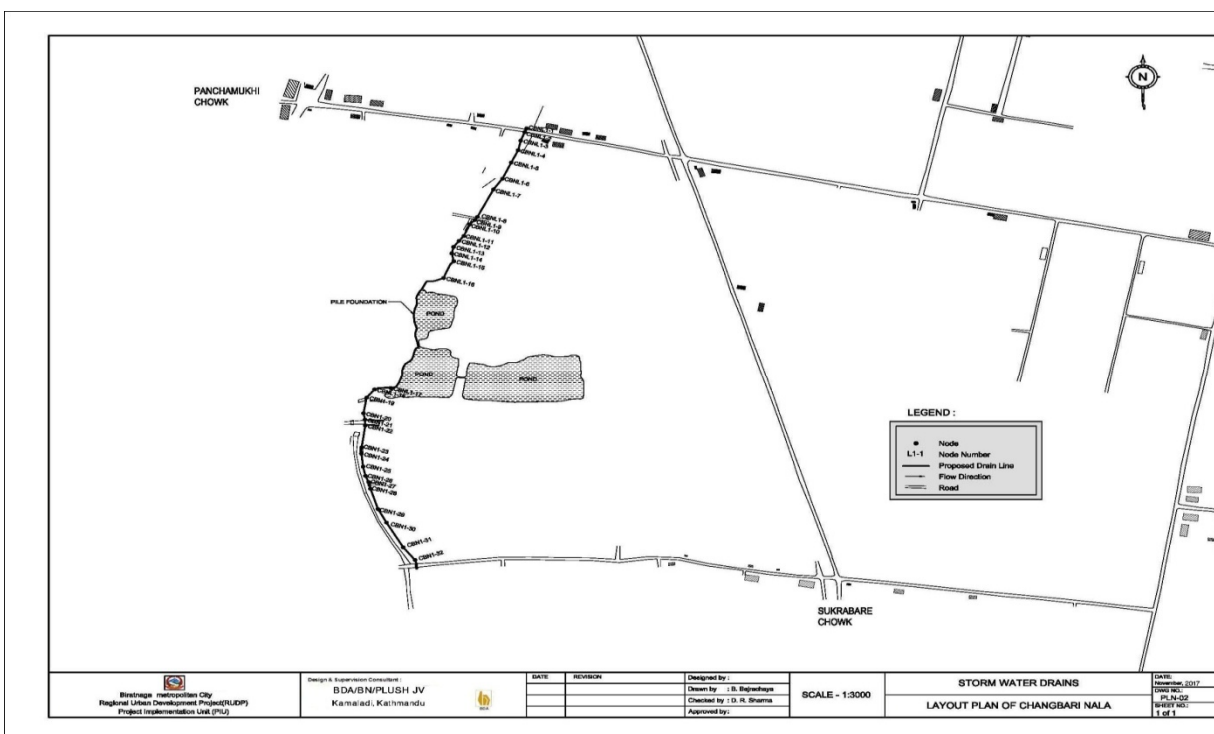
**Figure 3: Storm Water Drainage Layout Plan**

10 A total of 652.8m storm water drainage is proposed under the RUDP. *Figure 3* presented below shows overall storm water drainage plan for BMC. All planned drainage system has already been constructed by STIEUIP except for 652.89 m which passes through the existing Chyangbari Nala (Sagarmatha tole to Sukrabare Hatiya). The right side of blue shaded area in the *Figure 3* is proposed under the RUDP. The existing ROW of the drainage will be sufficient to improve the proposed section. There are no registered private lands, tenants and sharecroppers or seasonal encroachers at either site of the proposed drain.

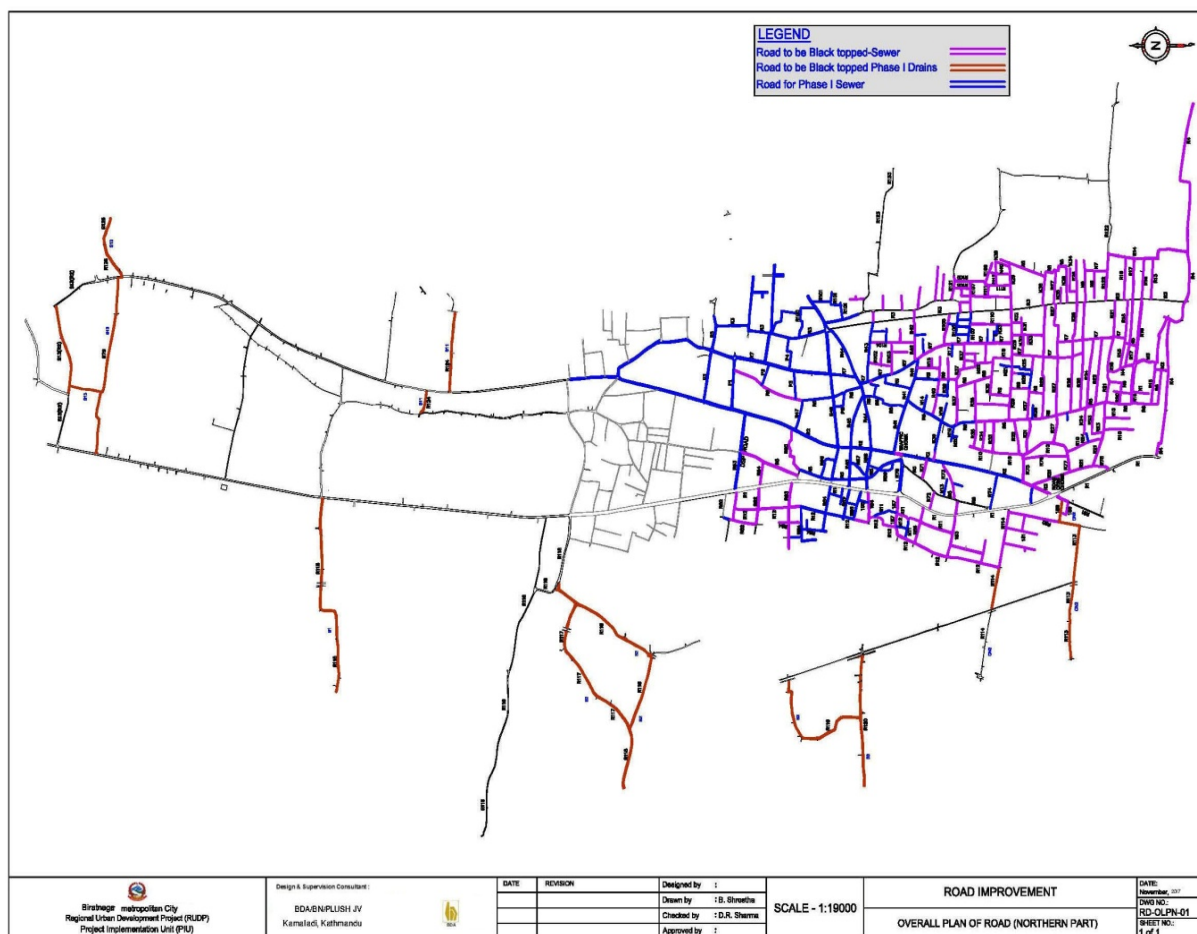
**Figure 4a: Overall Layout Plan of Road Improvement Networks (Northern part/main road)**

11 A total of 74 km road improvement is proposed in the RUDP. The roads included for improvements are those roads which were damaged due to pipeline installation, storm drain construction and other project related works of STIUEIP and couldn't be restored due to unavailability of funds. The overall road network layout plan is shown in *Figure 4a and 4b*.

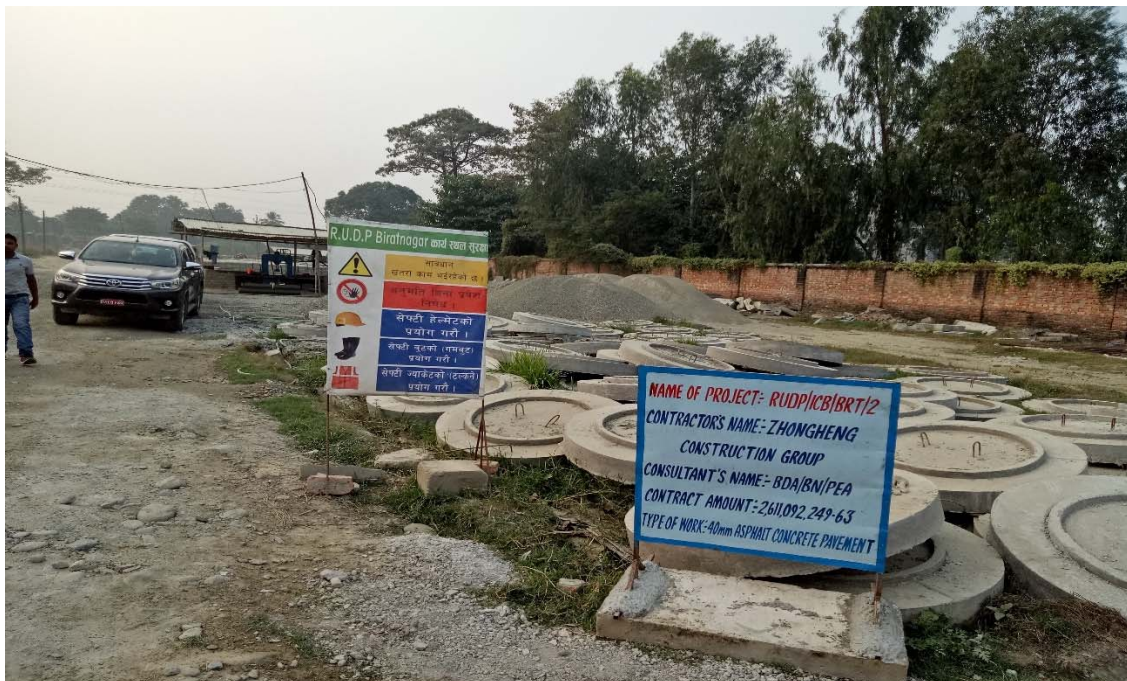
*Photo 1: Safety Information board and Project information board in Precast yard*

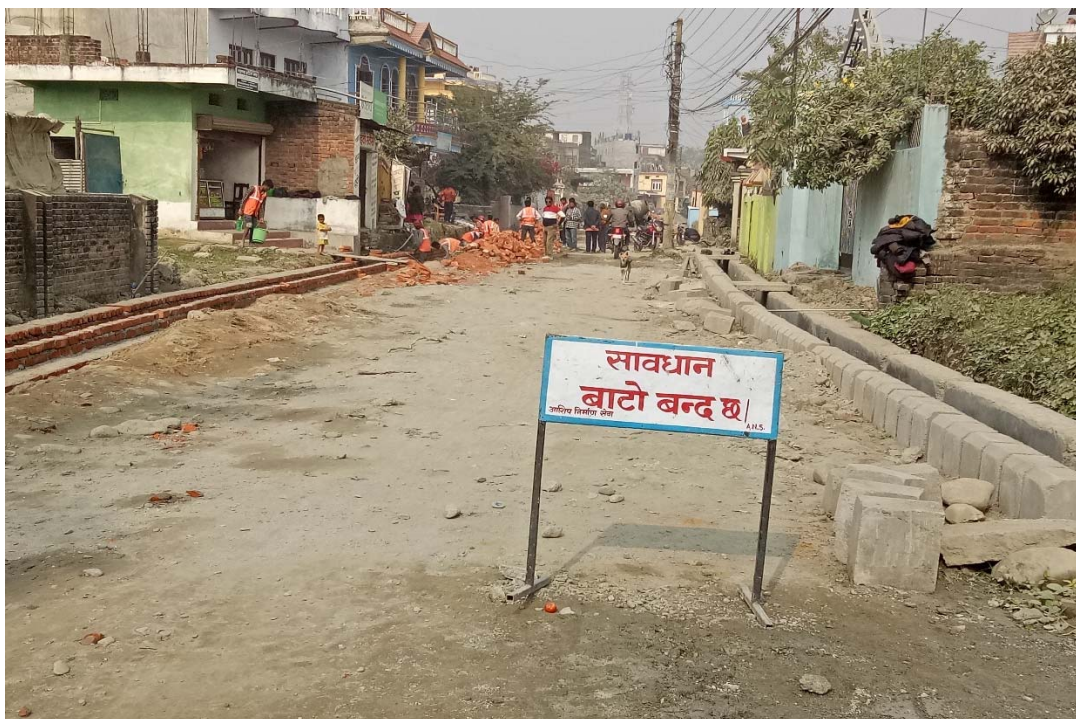
*Photo 3: Road Side Drain Under construction*

30 Constructed road side drains were covered with cover slab, however in few sections along the road drains were left open, where there may be problem for pedestrian and may chance of falling of pedestrian into drain. Therefore, contractor instructed to cover the open drain after cleaning drain bed immediately with slab cover.

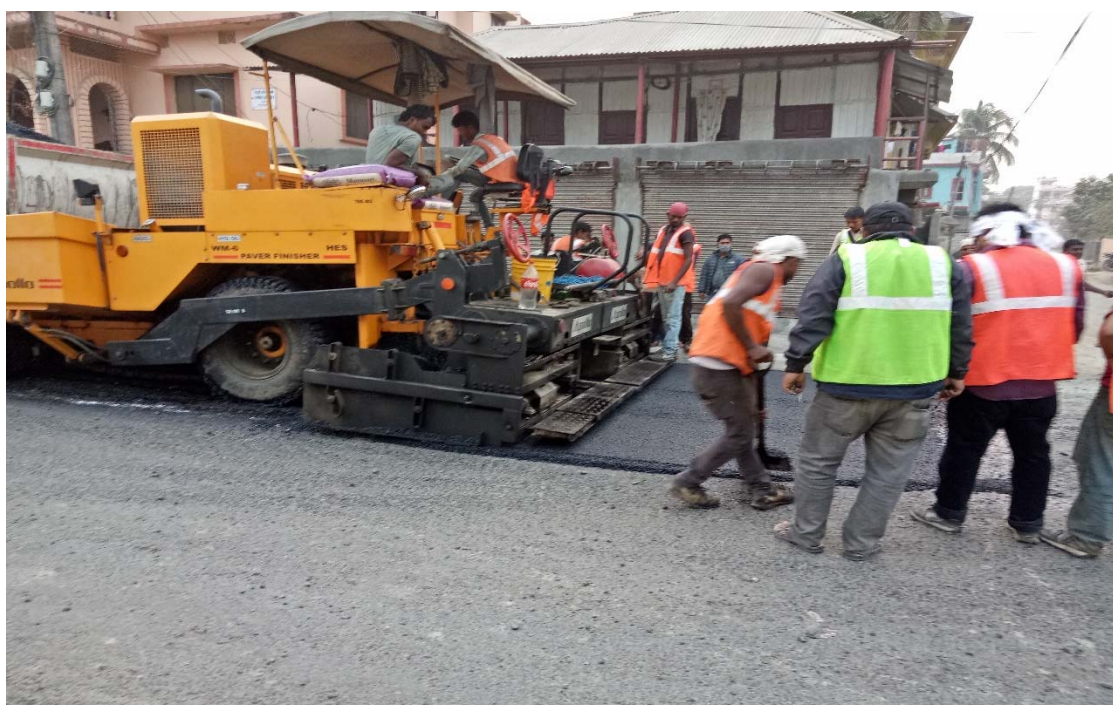
*Photo 3: Asphalt pavement work under progress*

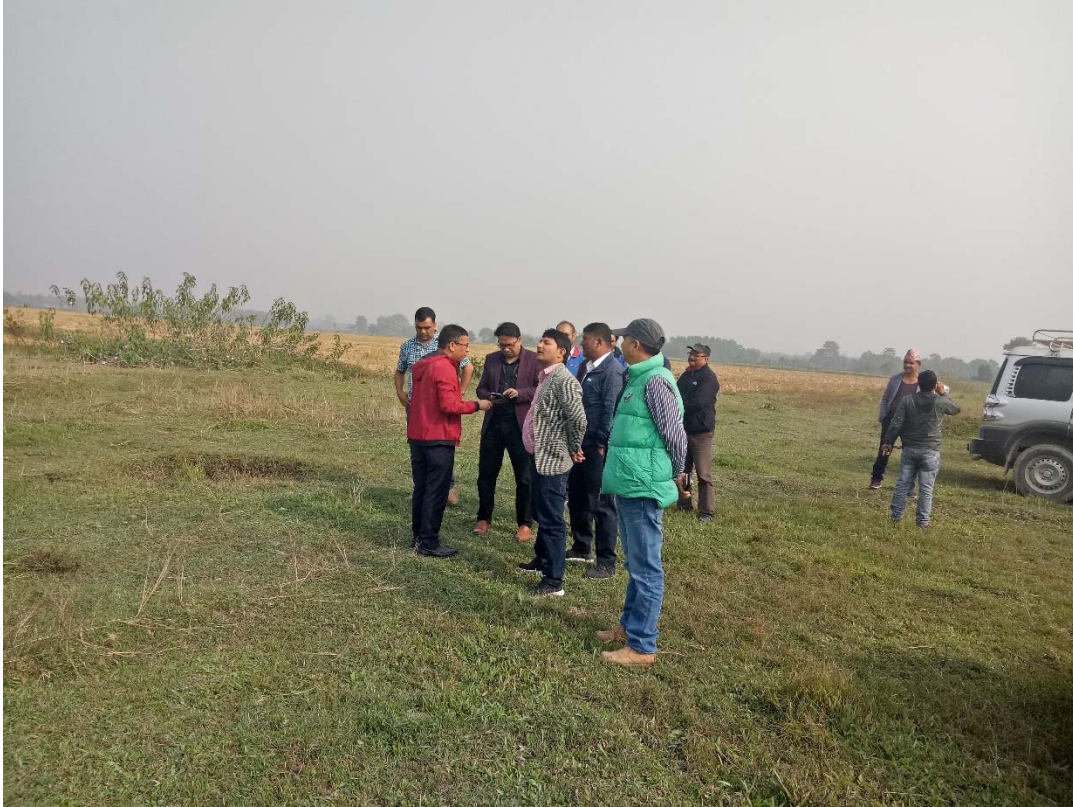
*Photo 5: Proposed site for Solid Waste Management at Dangraha*
